GREIFSWALD
MOOR
CENTRUM

Introduction to the excursion

„Karrendorf meadows“ - a successful coastal wetland restoration project

***Christof Herrmann
Agency for Environment, Nature
Conservation, and Geology***

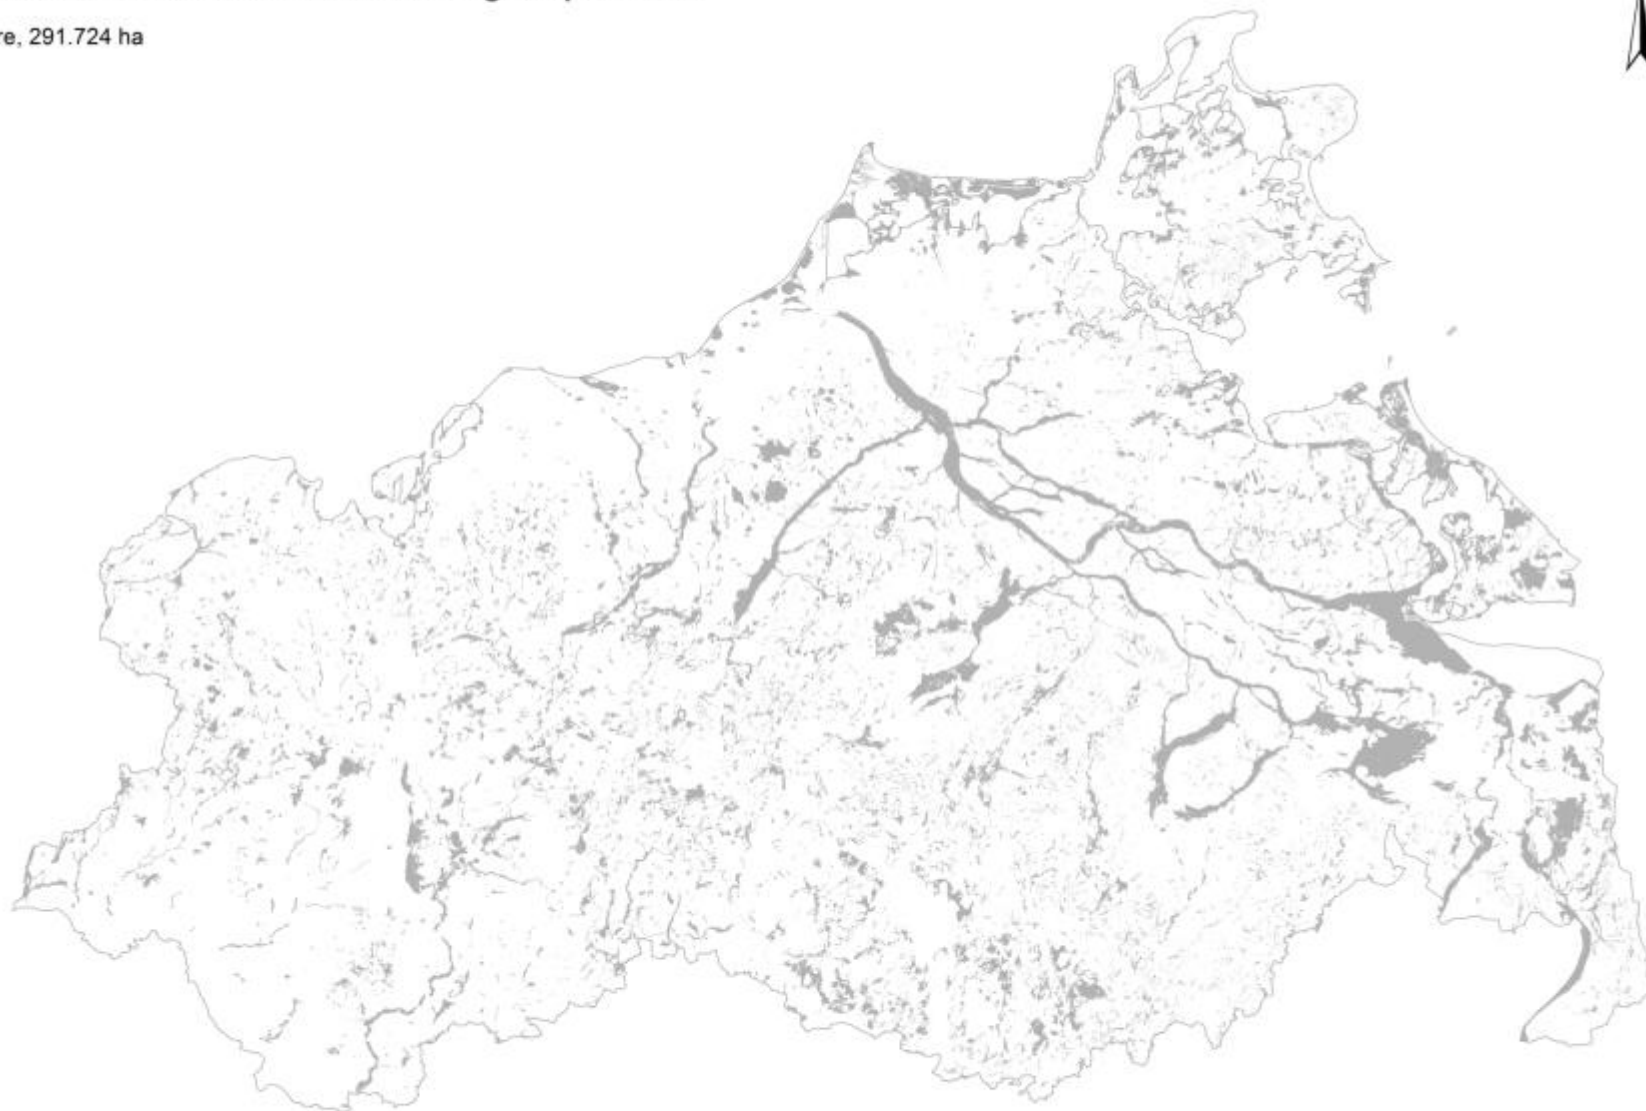
Aktualisierte Moorkarte von Mecklenburg-Vorpommern

Moore, 291.724 ha

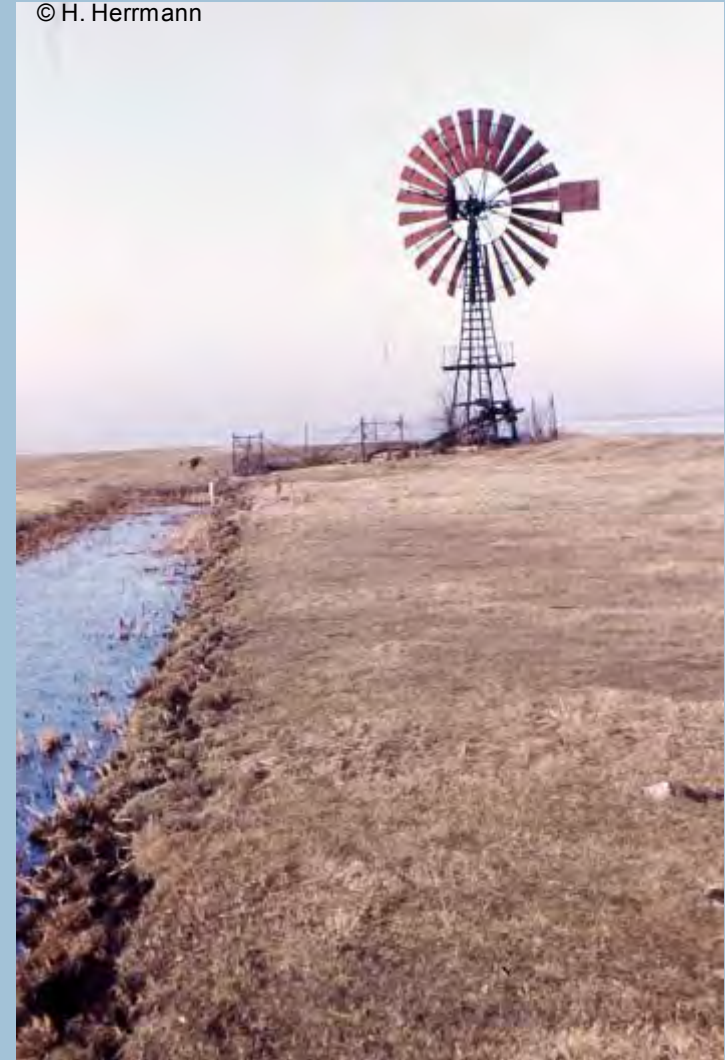
History: Dyking and drainage of a coastal fen

- The Swedish register map from 1697 already shows some artificial ditches; at that time, the meadows were used as pastures and for mowing
- Around 1820, enhancement of the drainage system through the development of ditches
- 1850/51 construction of summer dykes; these were severely damaged during the storm floods 1872 and 1874; they were rehabilitated in 1910
- During the 1920s, construction of two wind-driven water pumps

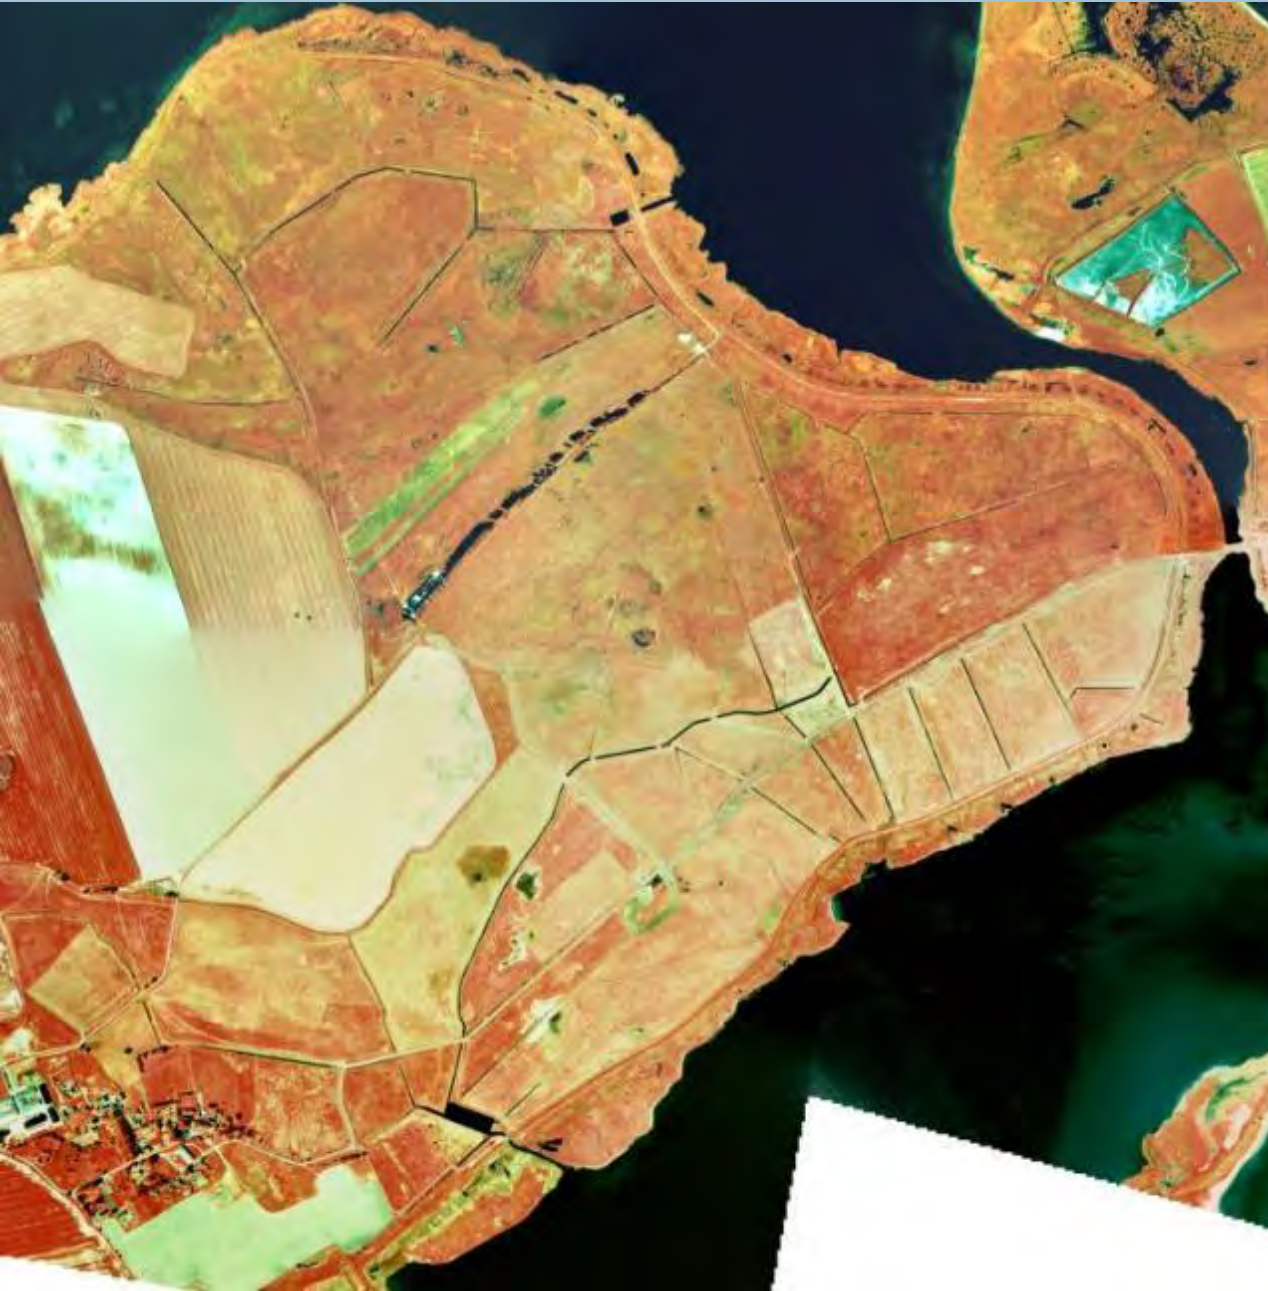
- The situation of the Karrendorf meadows in 1991 still reflects the results of the amelioration efforts during the 1970s.
- In 1988/89, the drainage system was reinforced
- 1987-1990 ploughing and sowing of perennial ryegrass.

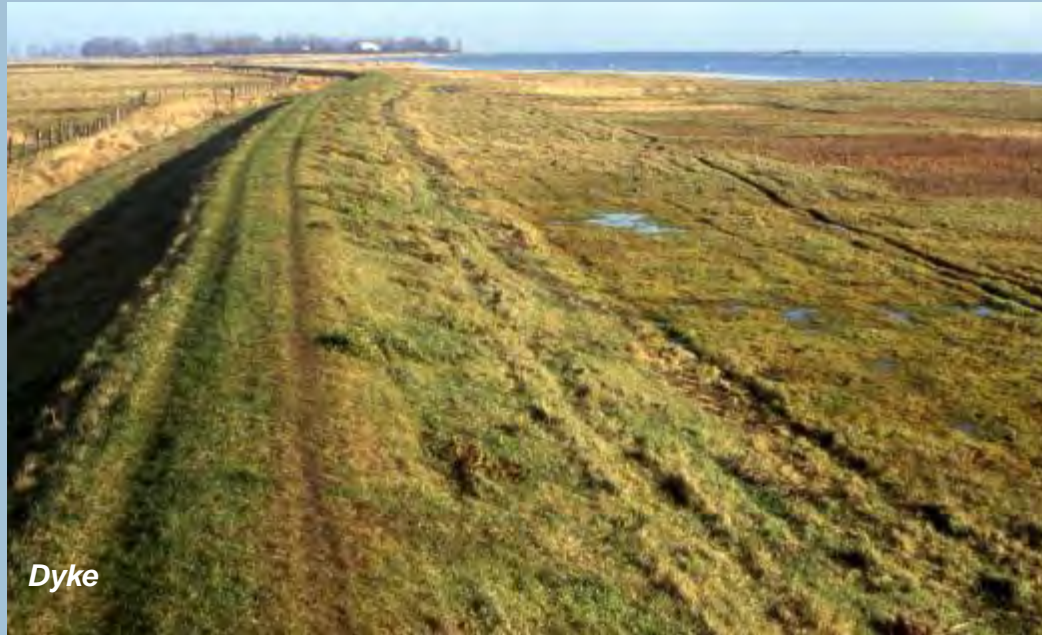
Dyke

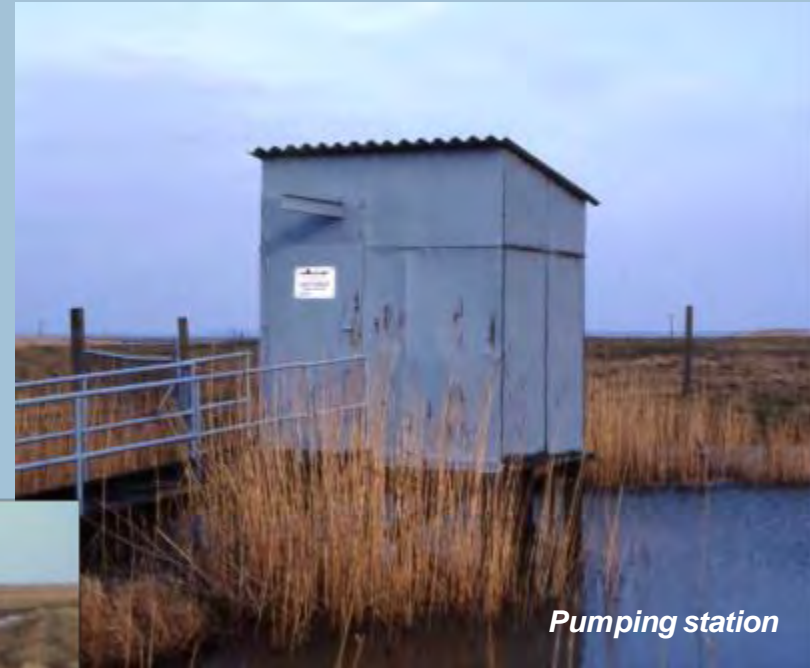
Pumping station

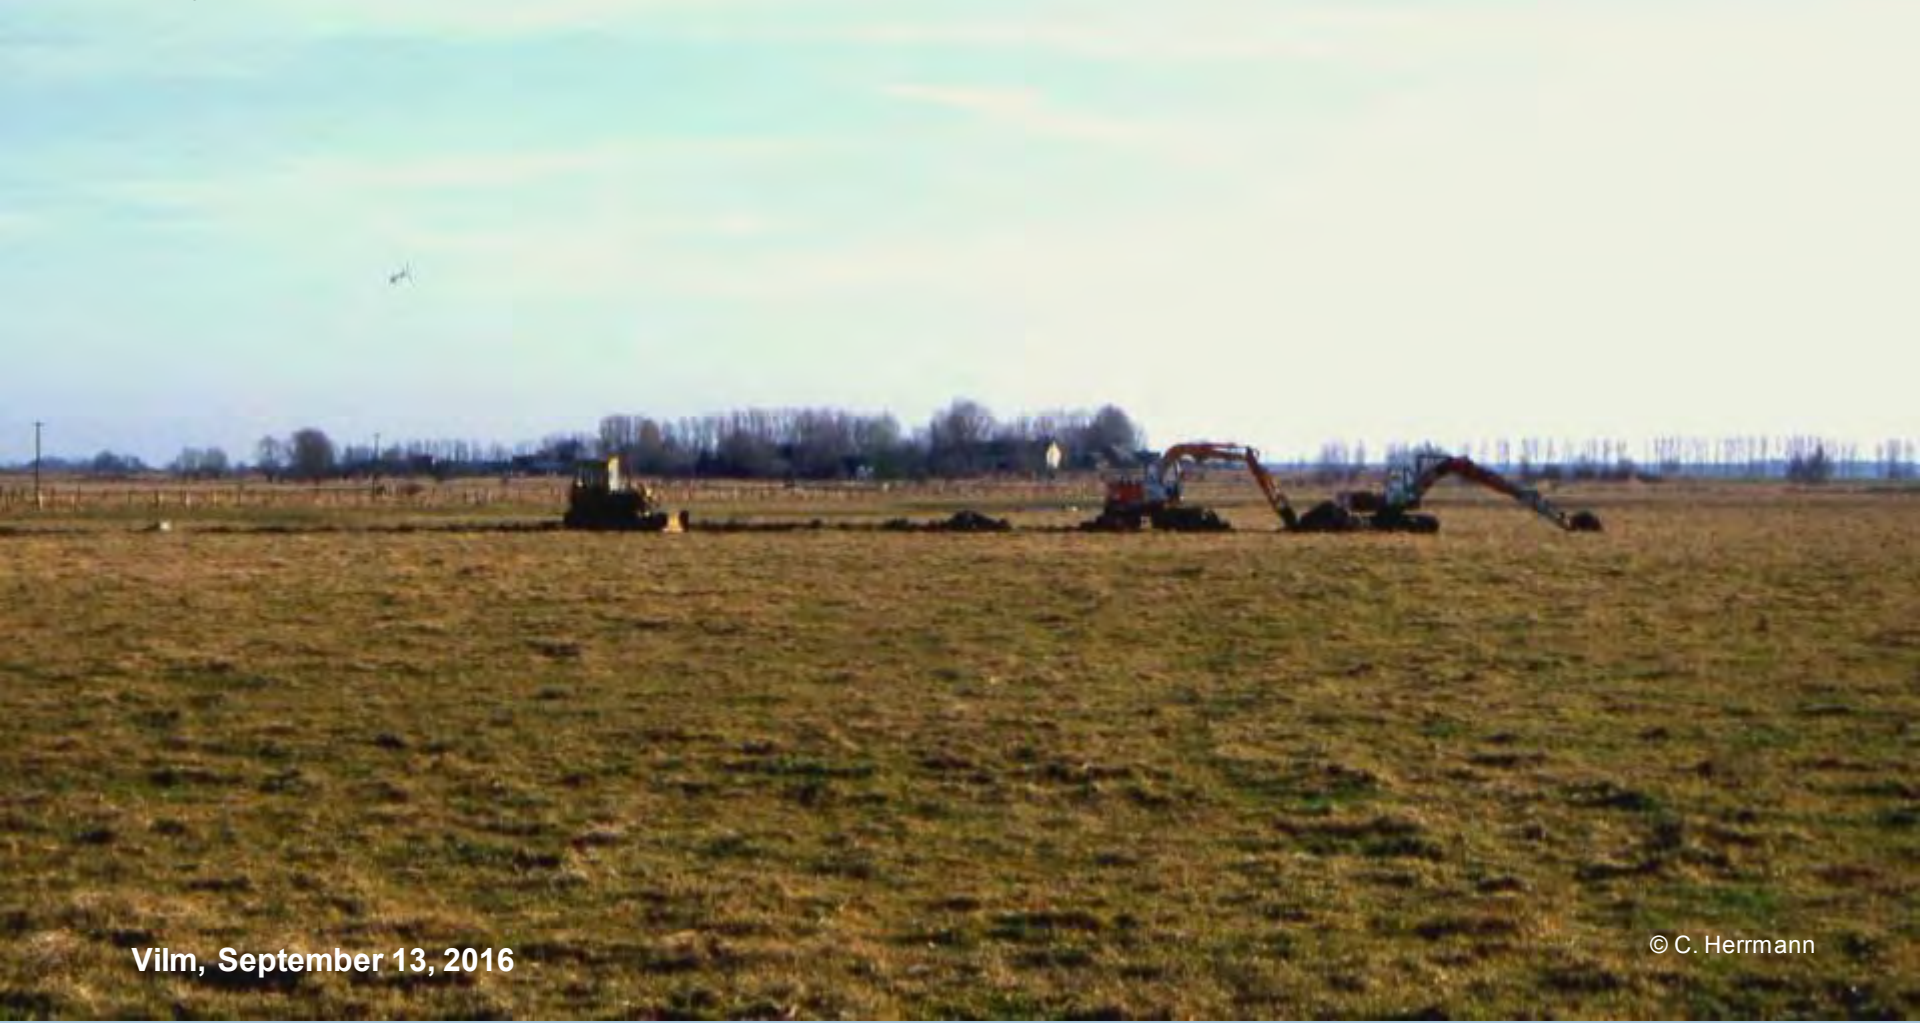
Restoration of Karrendorf meadows – actions taken: Jan. - March 1993: Construction of a new dyke for the future protection of the village Groß Karrendorf

January 1993: Start of the construction works

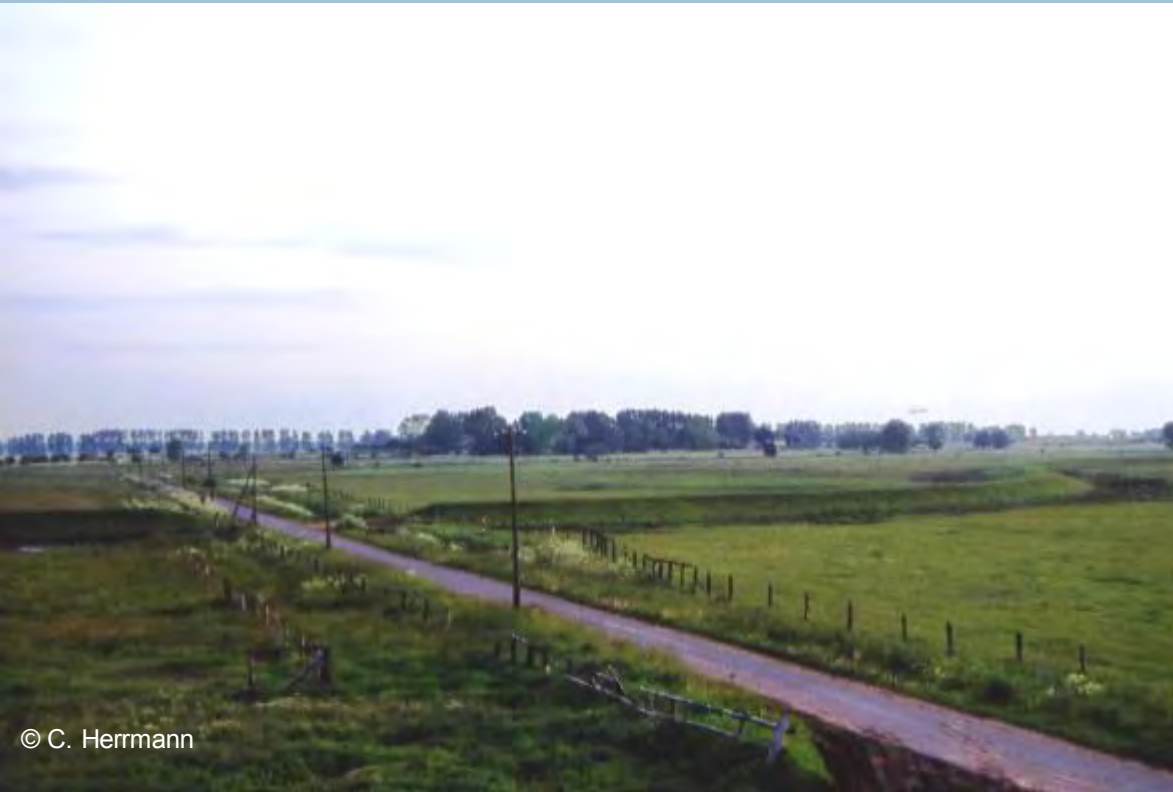
**Restoration of Karrendorf meadows – actions taken:
May 1993: The new dyke is covered by grass vegetation;
burial of telephone and electric cables**

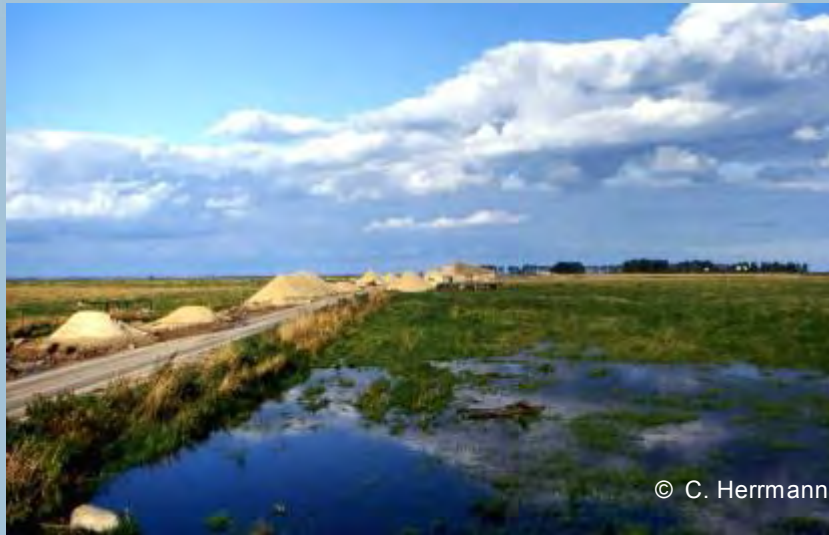
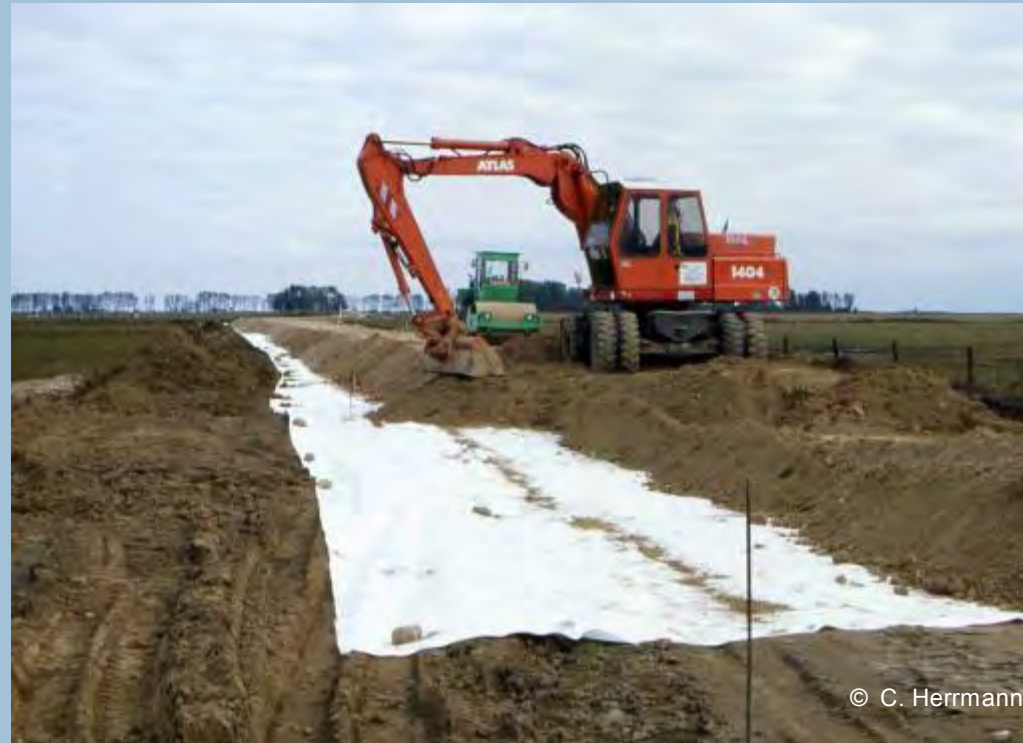
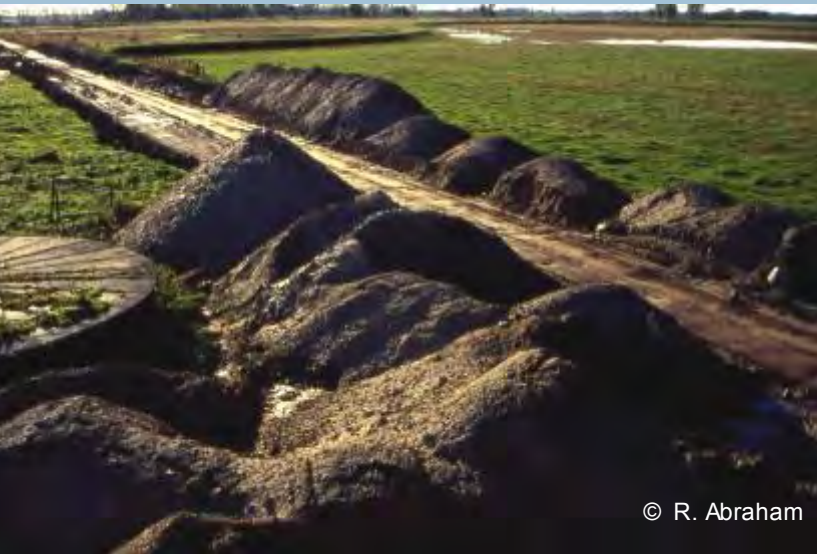
Restoration of Karrendorf meadows – actions taken: Sept.-Oct. 1993: Elevation of the road to 1,30 m above zero

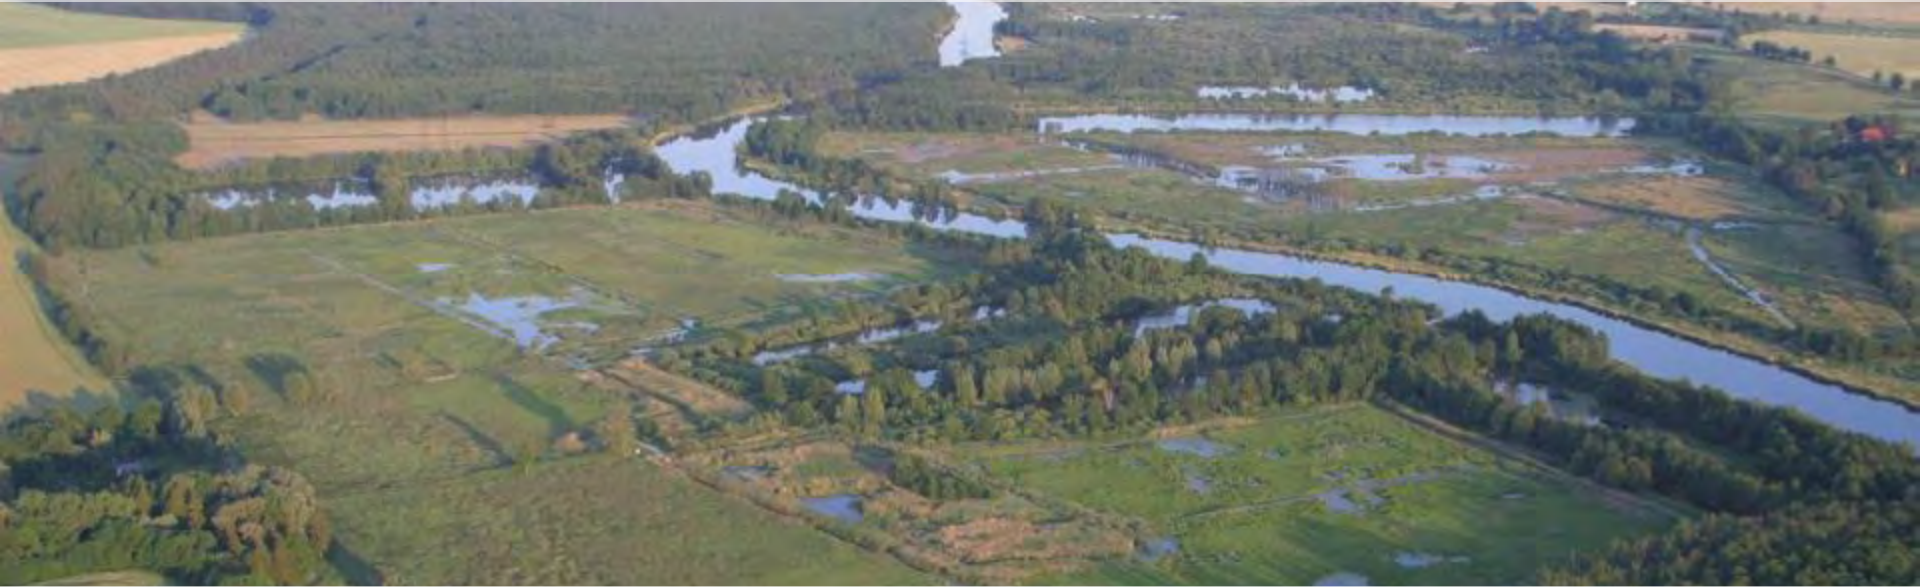
Peatlands in Peene Valley

- very small hydraulic gradient (20 cm over 85 km)
→ fen complex of ~18,000 ha
- centuries of low-intensity mowing/grazing
- 1930's: polders, after 1960's deep drainage
- 1992-2009 restoration of c. 10,000 ha (27 Mio Euro) → Nature Reserve of c. 20,000 ha (and Nature Park)
- but not (yet?) a Ramsar site...
